PORT COMMISSION AGENDA REGULAR MEETING MAY 9, 2018 AT 7:00PM VENTURA PORT DISTRICT OFFICE 1603 ANCHORS WAY DRIVE, VENTURA, CA

Ventura Port District
Ventura Harbor Commercial Fish Pier Condition Assessment
Job No. 887-18

Report for
Noble Consultants, Inc.
2201 DuPont Drive #830, Irvine, California 92612

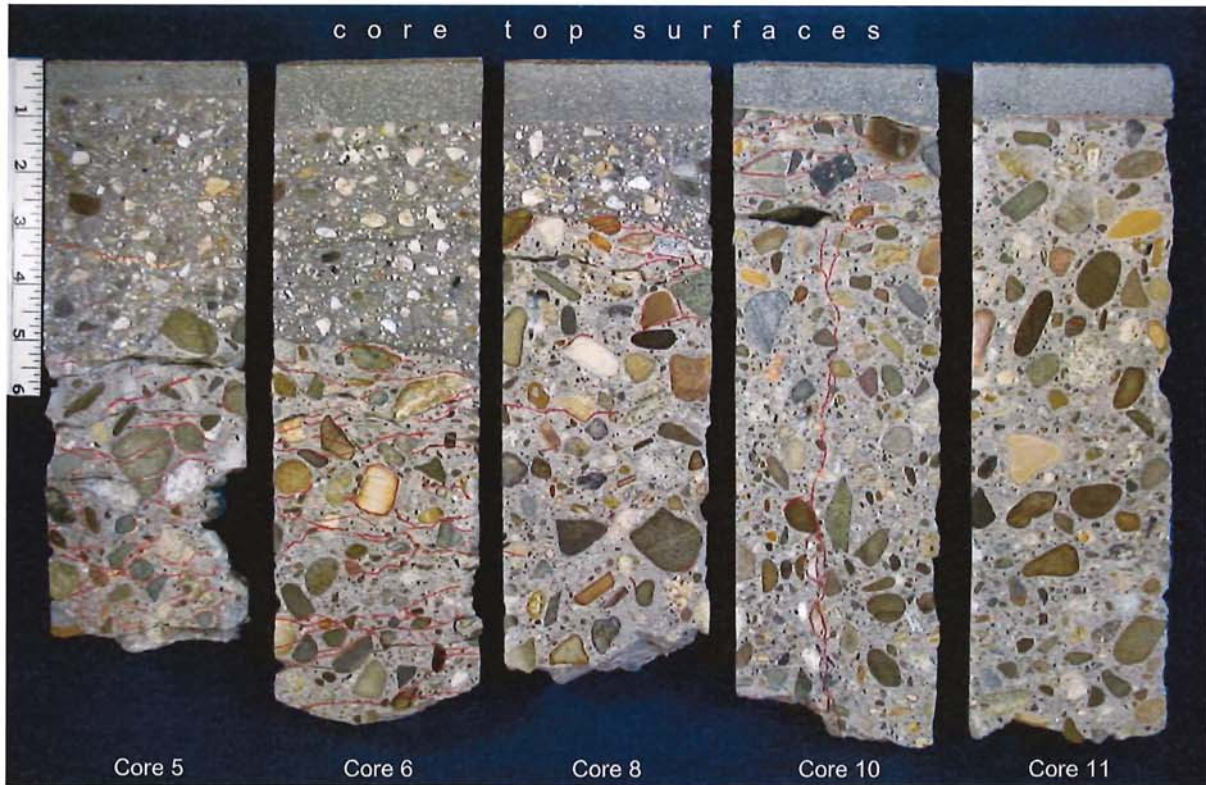
Fig. 1 Side by side comparison of lapped, cross-sectional (longitudinal) concrete surfaces of Cores 5, 6, 8, 10, and 11. All cores have a mortar topping system. Cores 5, 6, and 8 also have a topping concrete (dark-medium gray paste concrete). The remainder of the cores consists of substrate concrete (tan paste concrete), which contains similar aggregate types among the 5 cores. The coarse aggregate is a natural gravel composed of a wide variety of similar rock types. The fine aggregate is a natural sand composed mainly of quartz and quartzite, with lesser amounts of similar rock types.

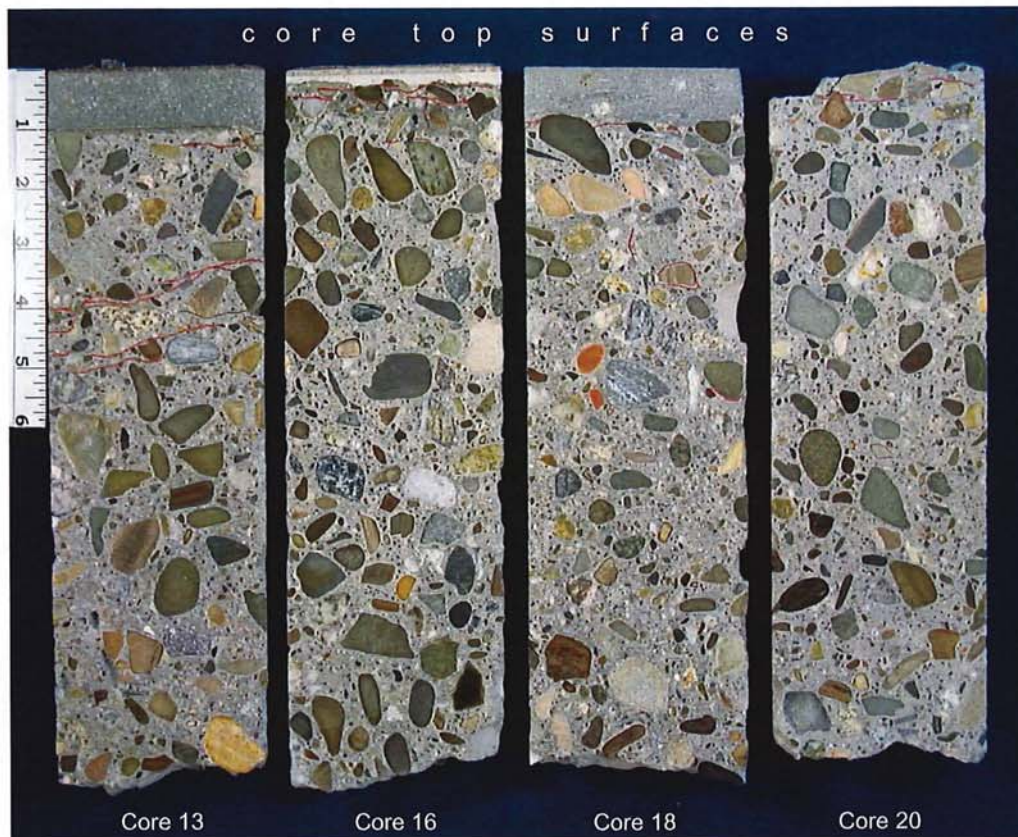
Fig. 2 Side by side comparison of lapped, cross-sectional (longitudinal) concrete surfaces of Cores 13, 16, 18, and 20. Cores 13, 16, and 18 have a topping system. The remainder of the cores consists of substrate concrete (tan paste concrete), which contains similar aggregate types among the 4 cores. The coarse aggregate is a natural gravel composed of a wide variety of similar rock types. The fine aggregate is a natural sand composed mainly of quartz and quartzite, with lesser amounts of similar rock types.

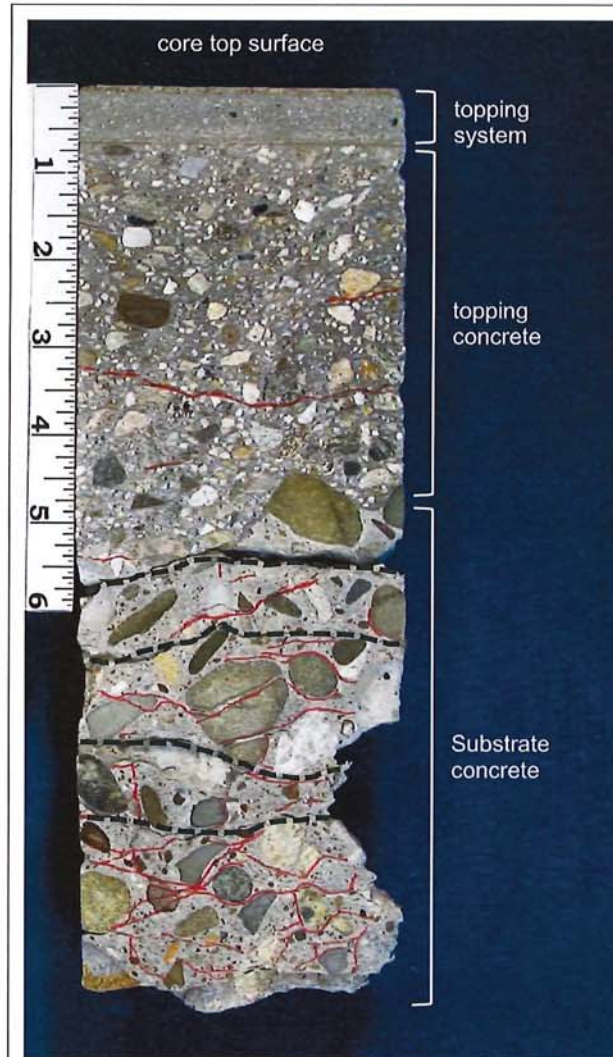
Fig. 3 Lapped, cross-sectional concrete surface of Core 5. From top to bottom, core consists of a topping system, topping concrete, and substrate concrete. Core was received fractured horizontally into 5 main segments within the substrate concrete; dashed-black lines depict the fractures. Microcracks (highlighted red) within the substrate concrete are substantial and are assessed to be ASR cracking. concrete. The microcracks are assessed to be ASR cracking.

Conclusive evidence of ASR and ASR-related deterioration is observed in Cores 5, 6, 8, and 10. The reactive aggregate types include mainly the opaline shale, and to a lesser extent the particles containing cryptocrystalline to high-strained quartz. In Cores 5 and 6 the ASR deterioration is substantial and is present throughout the depth of the substrate concrete. In Cores 8 and 10 the ASR deterioration is present in the top 2 to 2.3 in. (Cores 10 and 8, respectively) of the substrate concrete. The deterioration includes horizontal full fracture cracking and horizontal microcracking. (Figs. 3 through 8.)

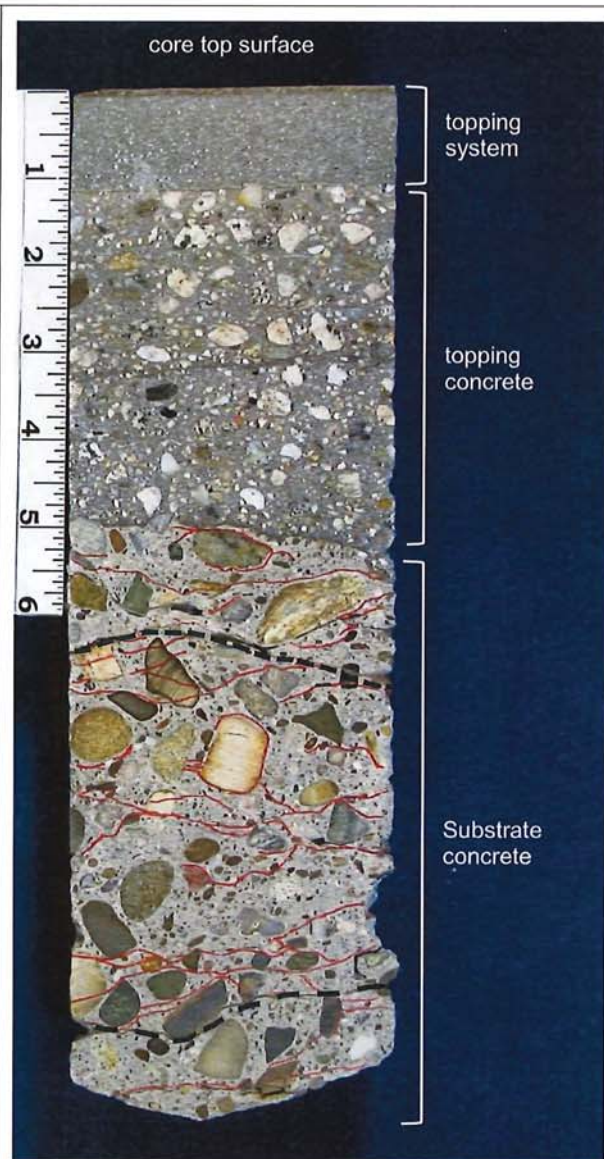
Fig. 4 Lapped, cross-sectional concrete surface of Core 6. From top to bottom, core consists of a topping system, topping concrete, and substrate concrete. Core was received fractured horizontally into 3 segments within the substrate concrete; dashed-black lines depict the fractures. Microcracks (highlighted red) within the substrate concrete are substantial and are assessed to be ASR cracking. fractured through end of core; cause for this crack is not discerned petrographically.

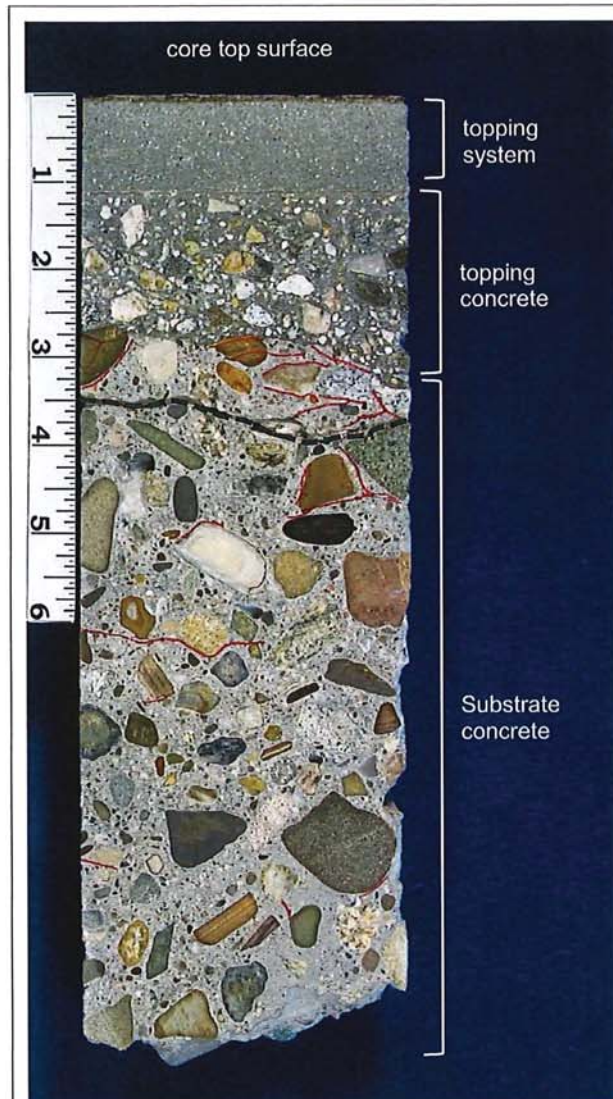
Fig. 5. Lapped, cross-sectional concrete surface of Core 8. From top to bottom, core consists of a topping system, topping concrete, and substrate concrete. Core was received fractured horizontally into 2 segments within the substrate concrete; dashed-black line depicts the fracture. Microcracks (highlighted red) are fairly common in the top 2.3 in. of the substrate concrete, and a few other microcracks are present in the remainder of the substrate concrete.

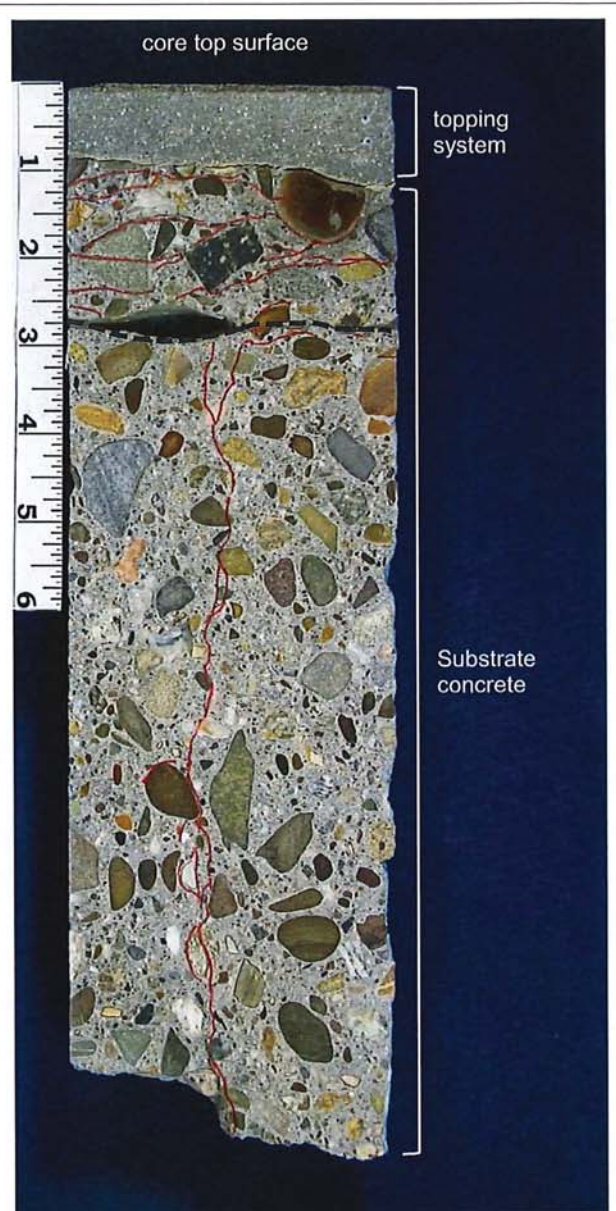
Fig. 6. Lapped, cross-sectional concrete surface of Core 10. The core consists of a topping system and substrate concrete. Core was received fractured horizontally into 2 segments within the substrate concrete; dashed-black line depicts the fracture. Horizontal microcracks (highlighted red) are very common in the top 2 in. of the substrate concrete; these are assessed to be ASR cracking. Vertical microcrack (highlighted red) extends from horizontal fracture crack through to the bottom of the core.

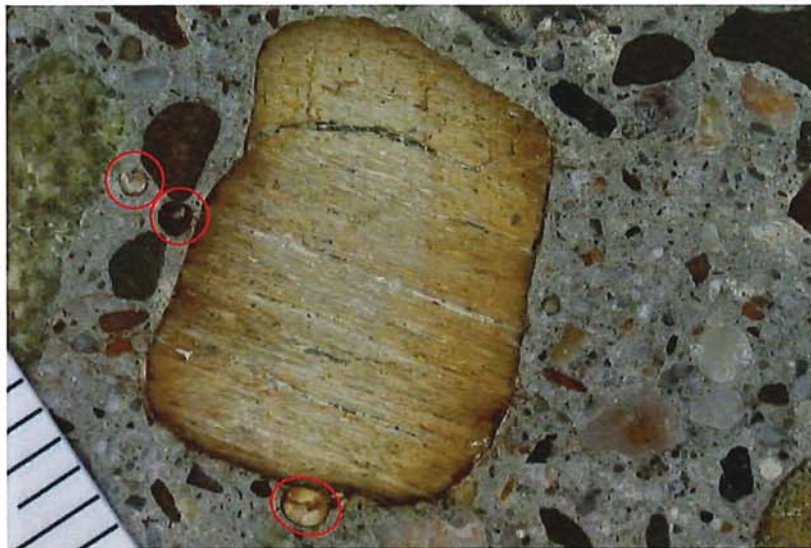
- 8a. A reacted opaline shale coarse aggregate particle exhibits a darkened rim. The white seam within the particle is ASR gel. Three adjacent air voids (encircled red) are filled with browned ASR gel.

Fig. 8 Close up images of sections of the lapped concrete surface of Core 6, illustrating evidence of ASR in the concrete.

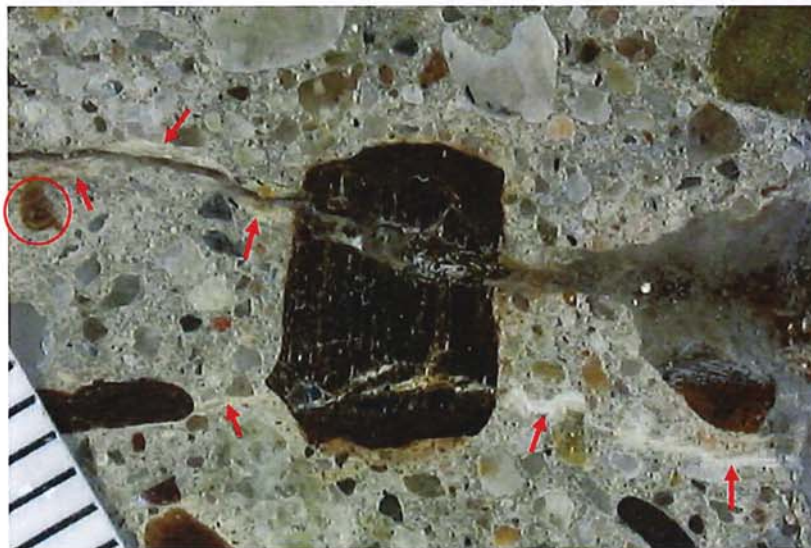
- 8b. A reacted opaline shale aggregate particle exhibits internal cracking, which extends out into the concrete. White ASR gel fills the cracking (red arrows). A nearby air void (encircled red) is filled with browned ASR gel.

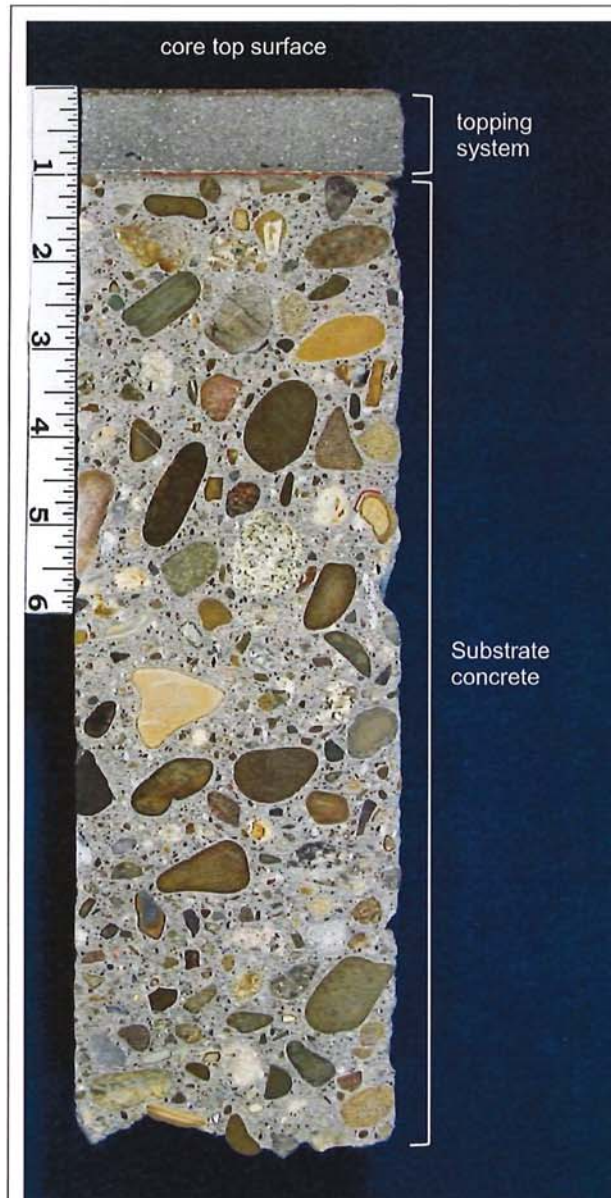
Fig. 9. Lapped, cross-sectional concrete surface of Core 11. The core consists of a topping system and substrate concrete. A horizontal microcrack (highlighted red) is present across much of the mortar topping-substrate concrete interface.

In Core 11 the mortar topping is debonded from the underlying substrate concrete; however, no other cracks or notable microcracks are present in the core. (Fig. 9.)

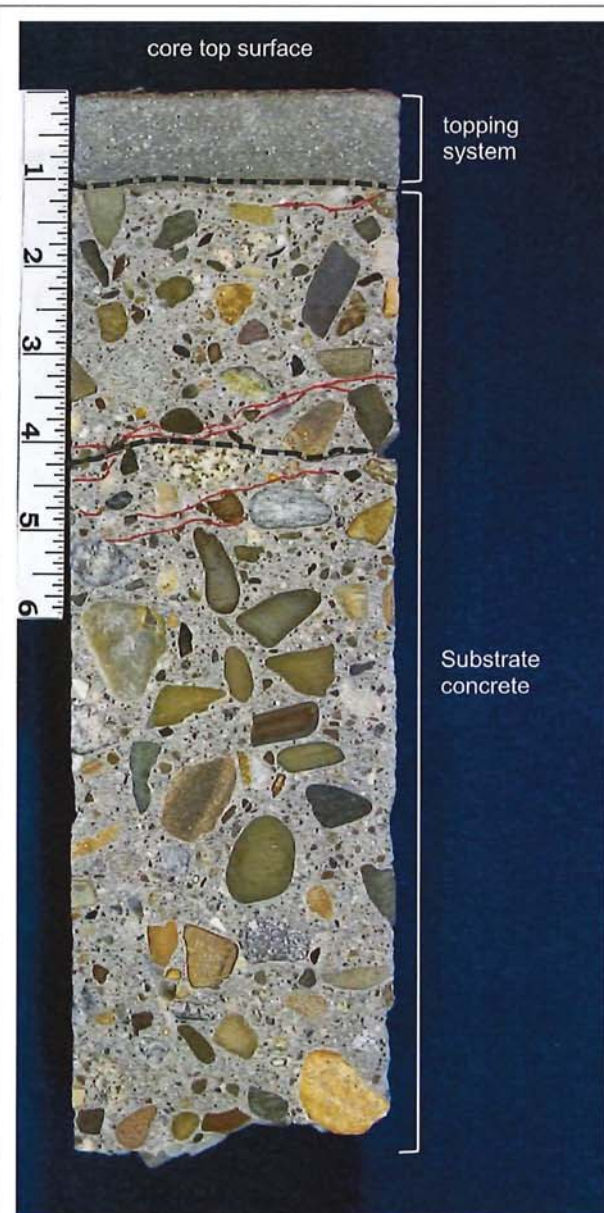
Fig. 10. Lapped, cross-sectional concrete surface of Core 13. The core consists of a topping system and substrate concrete. Core was received fractured horizontally into 3 segments; dashed-black lines depict the fractures. Several horizontal (at slight angle) microcracks occur near the full fracture crack, several above and several below within a substrate concrete depth interval of 2.2 to 4 in. Another horizontal microcrack is present in the top 0.3 in. of the substrate concrete. These microcracks may or may not be ASR-related.

- Core 13. A horizontal full-fracture crack is present at a substrate concrete depth of approximately 3 in. Several fairly horizontal (at slight angle) microcracks surround the full-fracture crack, several above the crack and several below the crack, within a substrate concrete depth interval of 2.2 to 4 in. The cause for this cracking is not discerned petrographically. Beyond the 2.2- to 4-in.-depth zone of cracking, no cracking is present, either above the zone or below the zone. This cracking behavior is not characteristic of ASR. In the absence of ASR gel, the cause for this cracking is not discerned in this examination. Also, one horizontal microcrack is present in the top 0.3 in. of the substrate; this crack could be a result of several different factors.

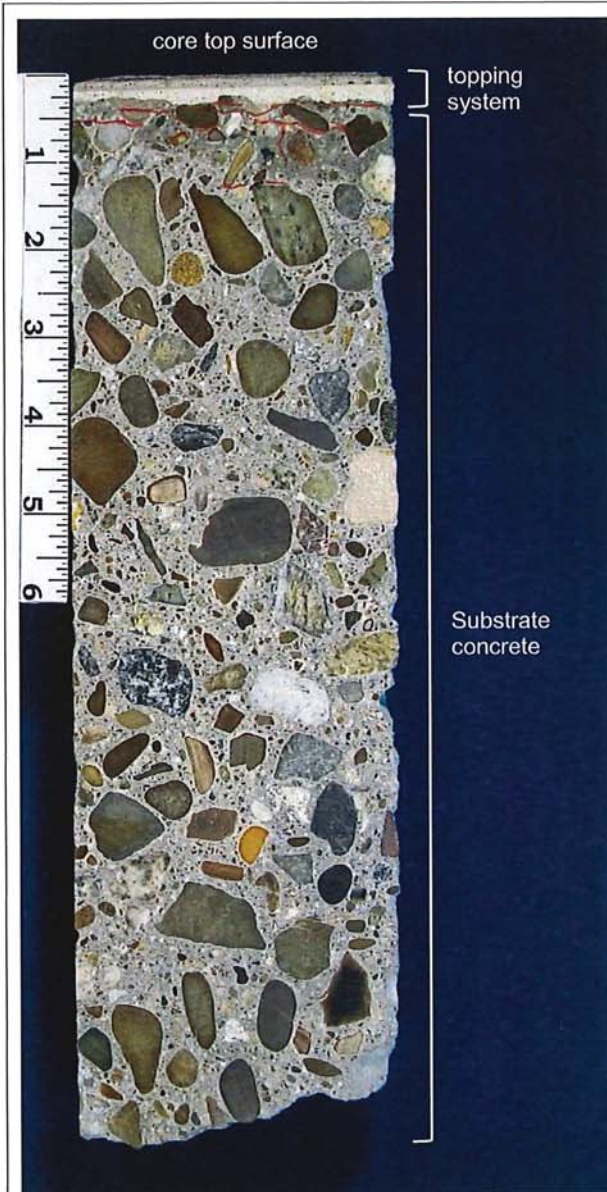
Fig. 11 Lapped, cross-sectional concrete surface of Core 16. The core consists of a topping system and substrate concrete. Some horizontal microcracks (highlighted red) are present in the top 0.9 in. of the substrate concrete. These microcracks may or may not be ASR-related.

- Cores 16 and 20. These two cores exhibit horizontal cracking in the near-surface region of the substrate concrete to depths of 0.9 in. in Core 16 and 0.6 in. in Core 20. Below these near-surface zones, no cracking is present in the remainder of the cores. This is not a typical cracking behavior that is characteristic of ASR. In the absence of ASR gel, the cause for this cracking is not discerned in this examination.

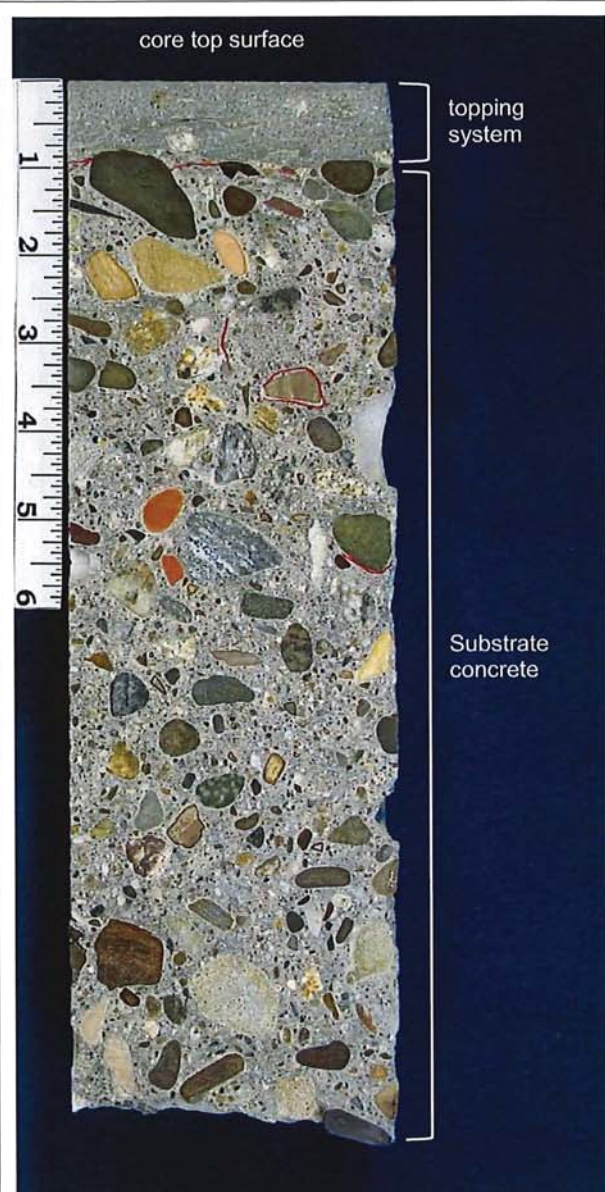
Fig. 12 Lapped, cross-sectional concrete surface of Core 18. The core consists of a topping system and substrate concrete. Microcracks are highlighted red. A horizontal microcrack is present along the mortar topping-substrate concrete interface and within the substrate concrete. A few other random, fairly short microcracks are present in the top 4.6 in. of the substrate concrete; they may or may not be ASR-related.

- Core 18. A few microcracks are present in the core. One horizontal microcrack is present along the mortar topping-substrate concrete interface, which also extends into the substrate concrete. The cause for this microcrack cannot be discerned. A few other random, fairly short microcracks are present in the top 4.6 in. of the substrate concrete. These random microcracks may or may not be due to ASR; however, no ASR gel deposits are observed to confirm ASR.

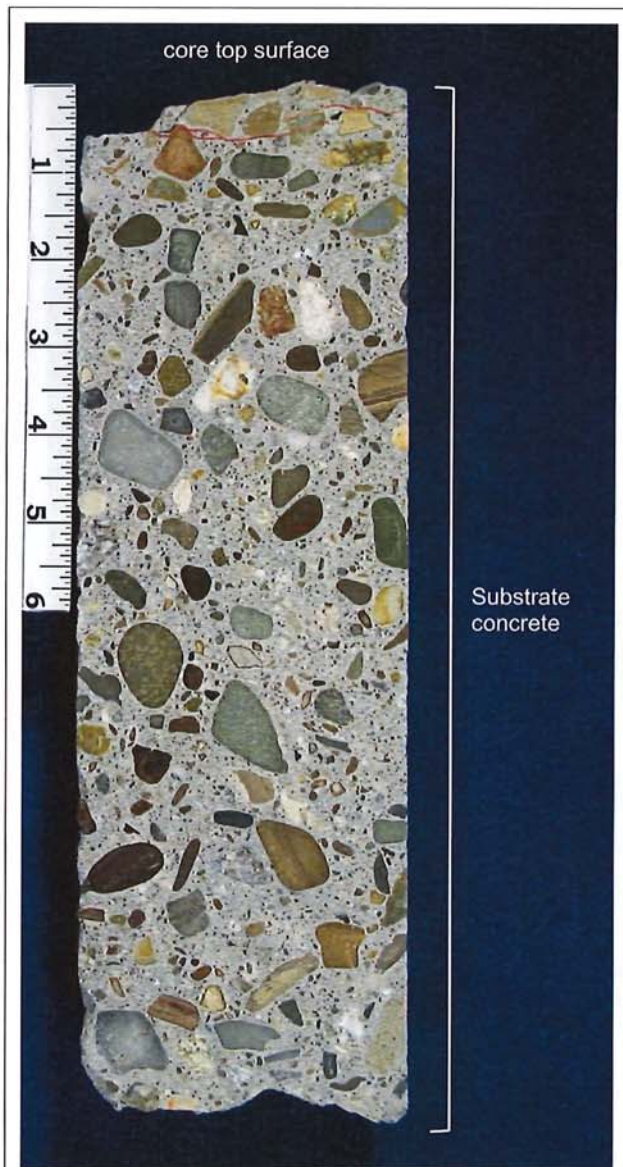
Fig. 13 Lapped, cross-sectional concrete surface of Core 20. The core consists of substrate concrete. A few horizontal microcracks (highlighted red) are present within the top 0.6 in. of the core. These microcracks may or may not be ASR-related.

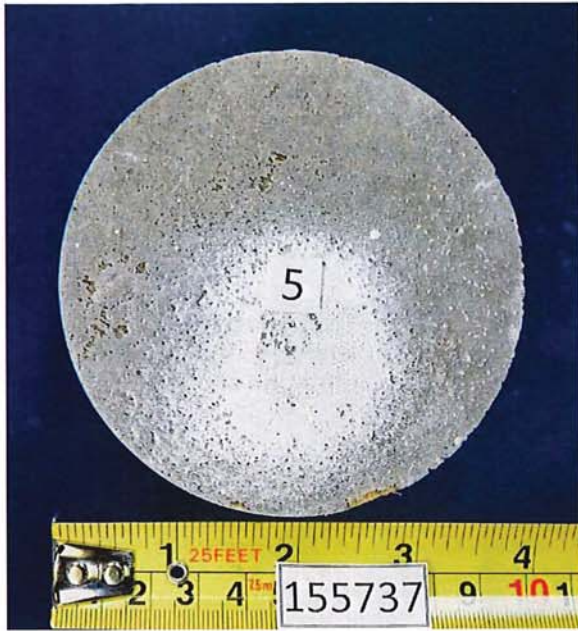
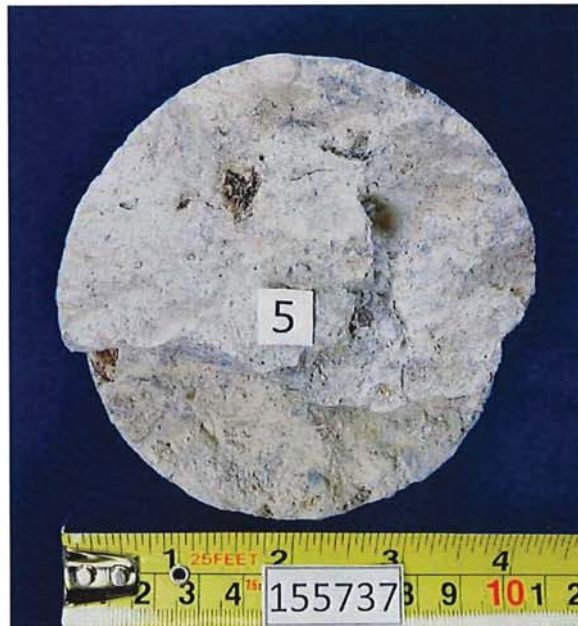
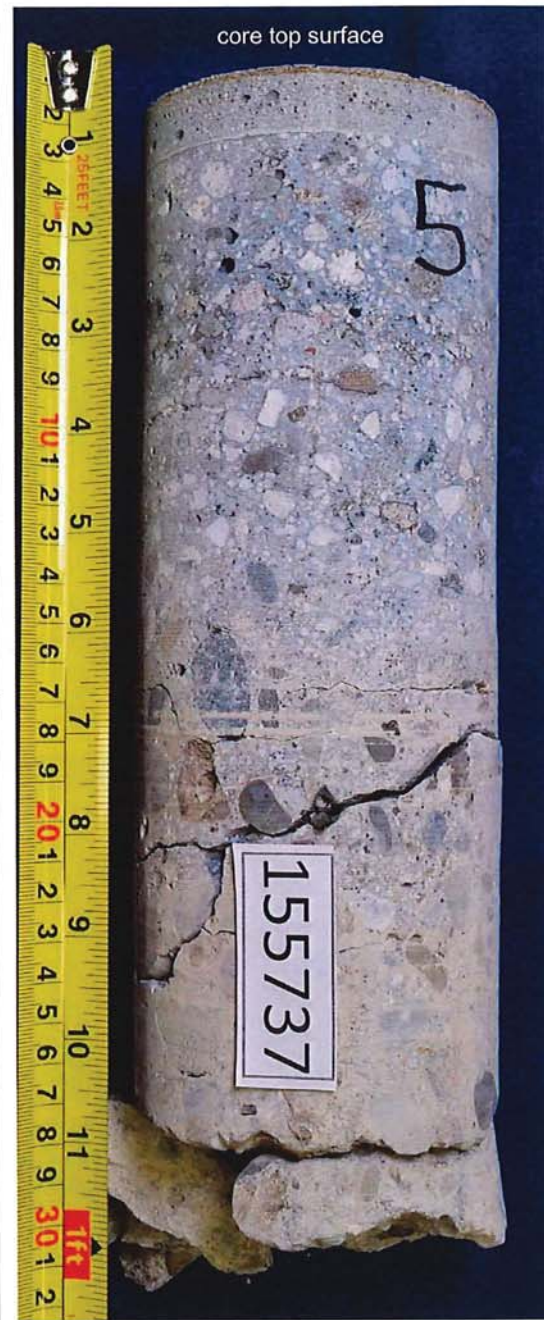
Fig. 5.1 Core 5, as received for testing.

ASR in Concrete: Substantial degree of ASR and substantial amount of ASR cracking throughout substrate concrete.

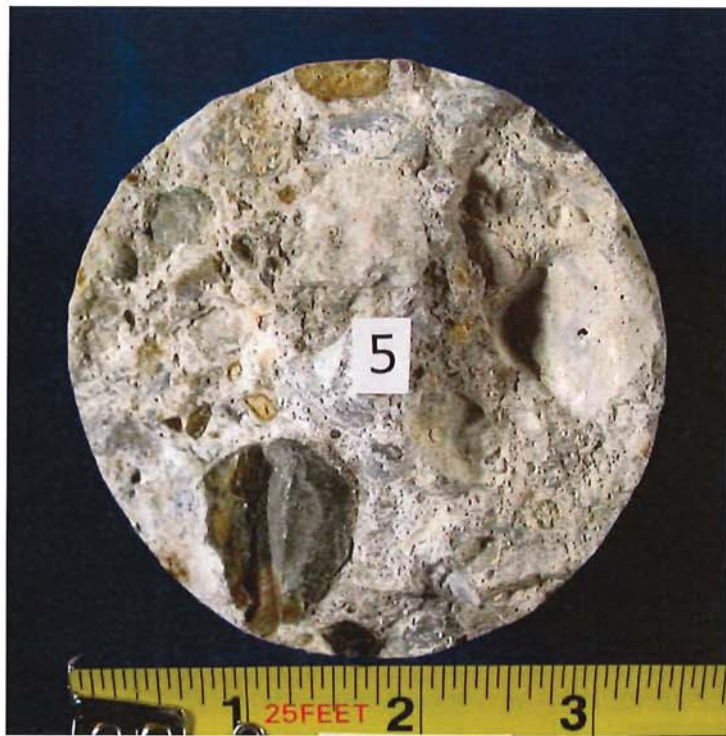
5.2.a. The surface is coated with white secondary deposits of ettringite and ASR gel.

Fig. 5.2 Two of the as-received fractured surfaces of Core 5, illustrating evidence of ASR within the concrete.

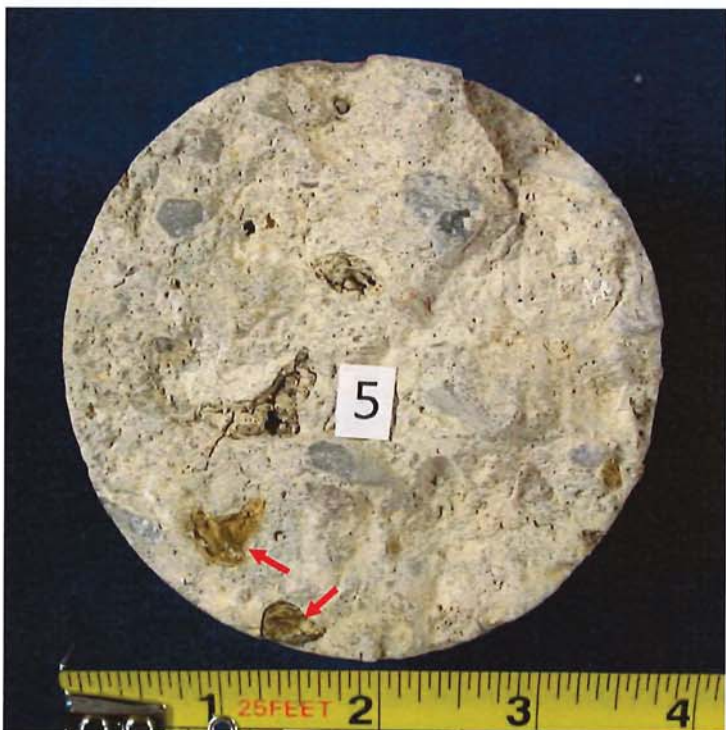
5.2.b. Several reacted coarse aggregate particles (red arrows) are present.

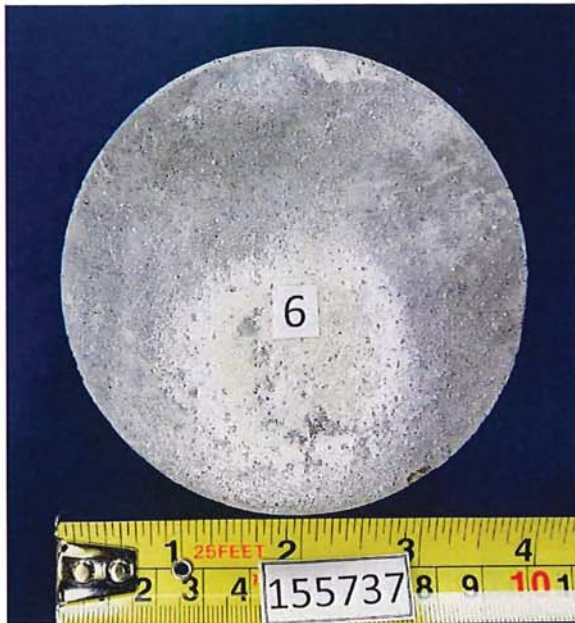
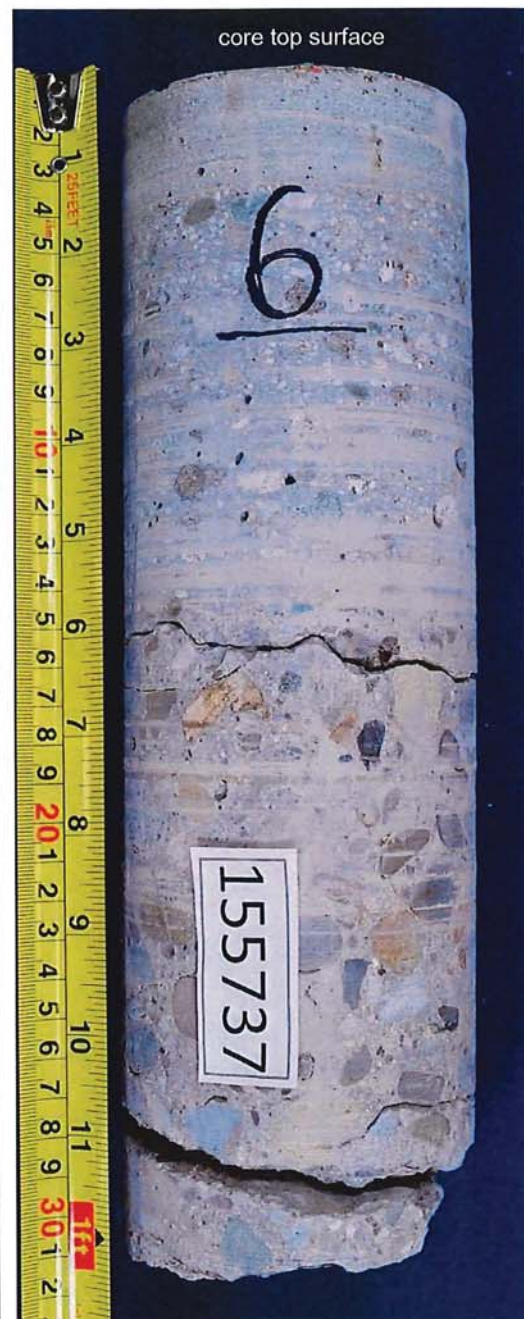
Fig. 6.1 Core 6, as received for testing.

ASR in Concrete: Substantial degree of ASR and ASR cracking throughout substrate concrete.

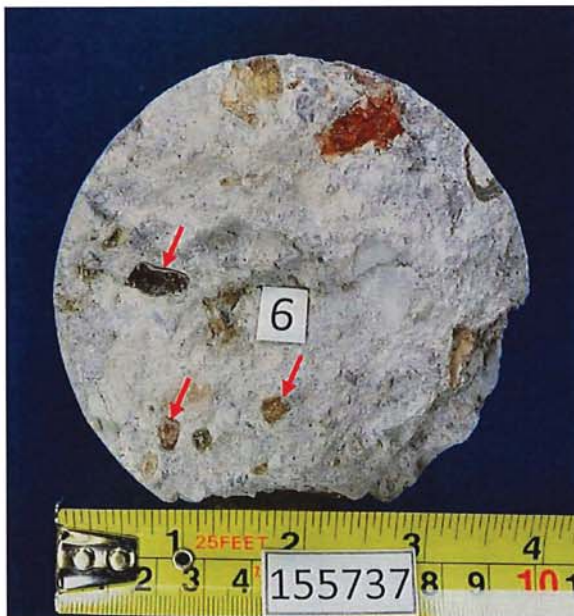
6.1.b. Core side surface. Several reacted aggregate particles (red arrows) are present.

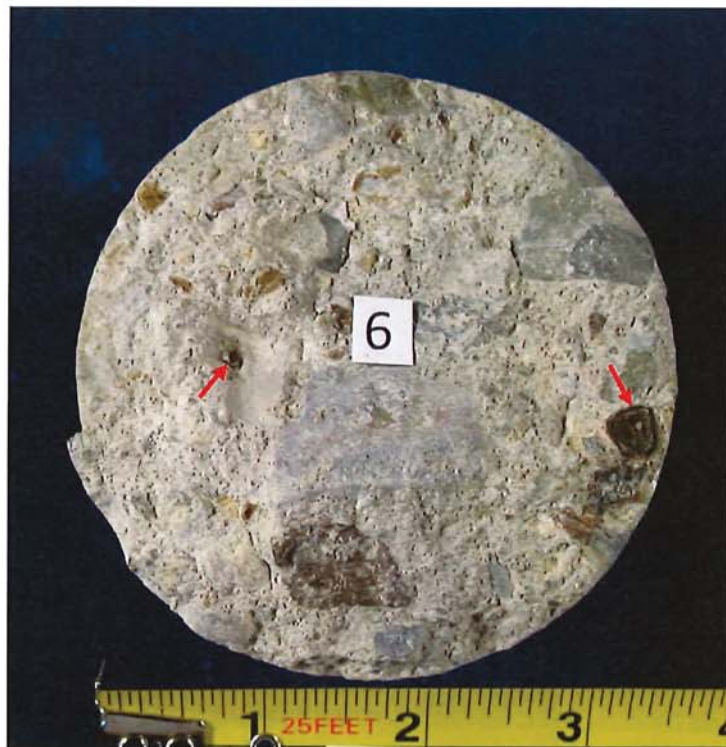
6.2.a. Red arrows depict two reacted opaline shale particle, one coarse aggregate and one fine aggregate. Note the aggregates' darkened rims.

Fig. 6.2 Two of the as-received fractured surfaces of Core 6, illustrating evidence of ASR within the concrete.

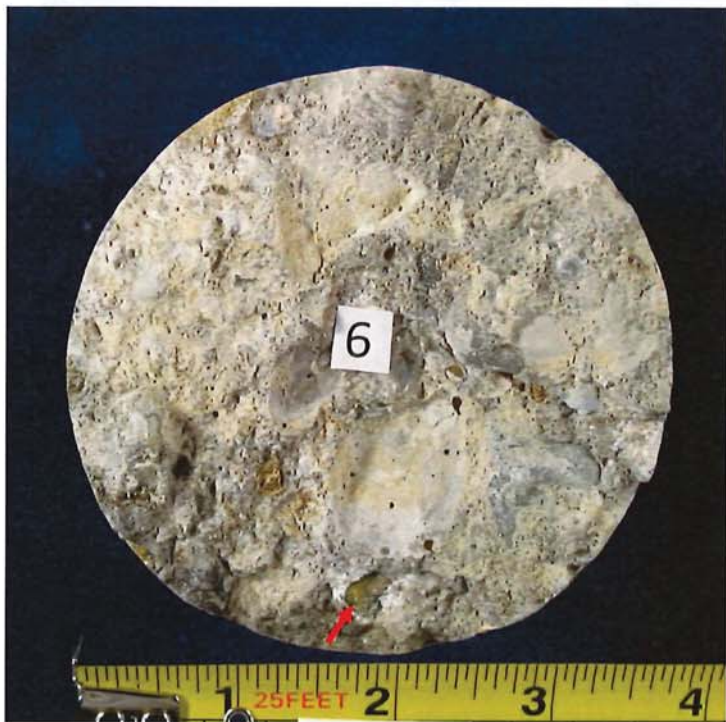
6.2.b. Red arrow points to a reacted coarse aggregate particle. Note the aggregate's darkened rim. White ASR gel and secondary ettringite surround the particle and extend further on the surface (red encirclement).

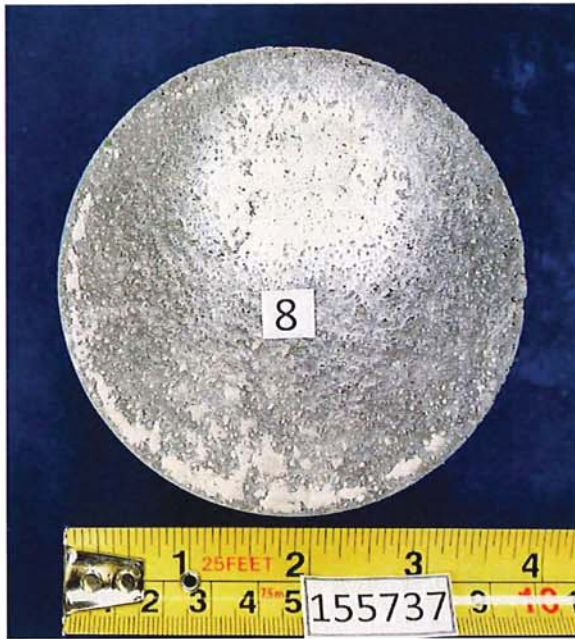
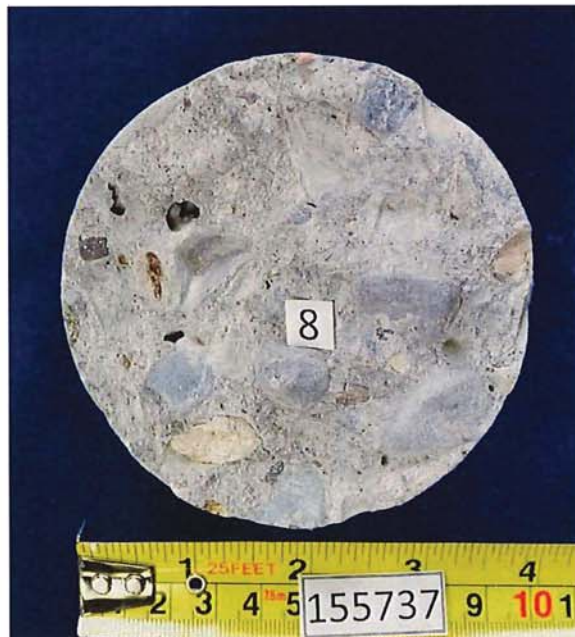
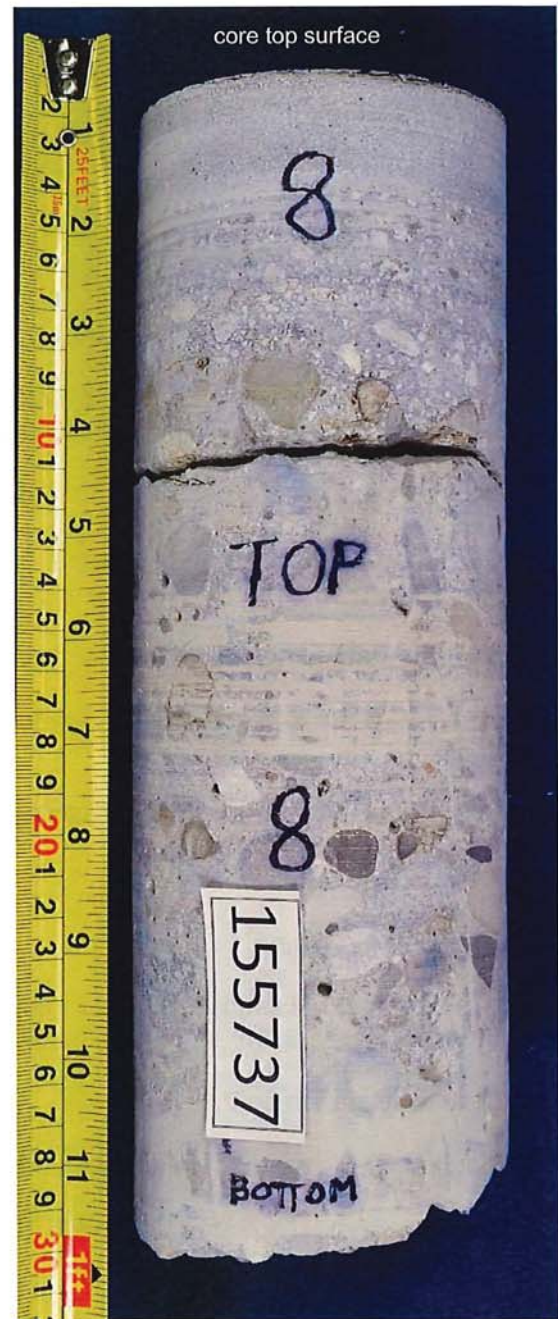
Fig. 8.1 Core 8, as received for testing.

ASR in Concrete: Moderately substantial degree of ASR and ASR cracking in top 58 mm (2.3 in.) of substrate concrete; very minor degree of ASR present in remainder of substrate concrete.

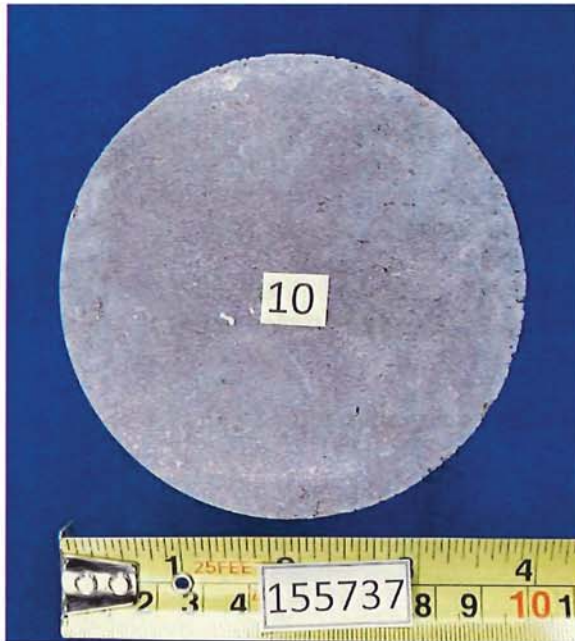
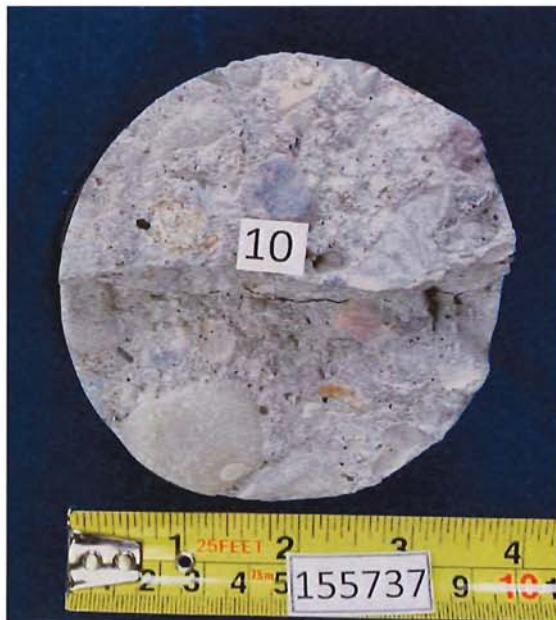
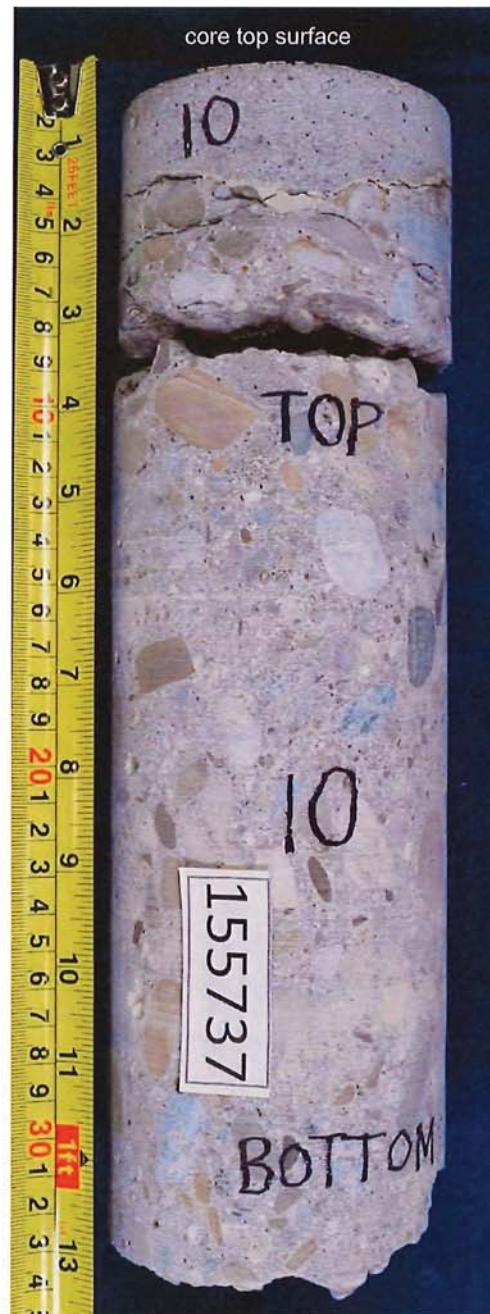
Fig. 10.1 Core 10, as received for testing.

ASR in Concrete: Substantial degree of ASR and associated cracking in top 50 mm (2.0 in.) of concrete. Essentially no evidence of ASR observed in remainder of substrate concrete.

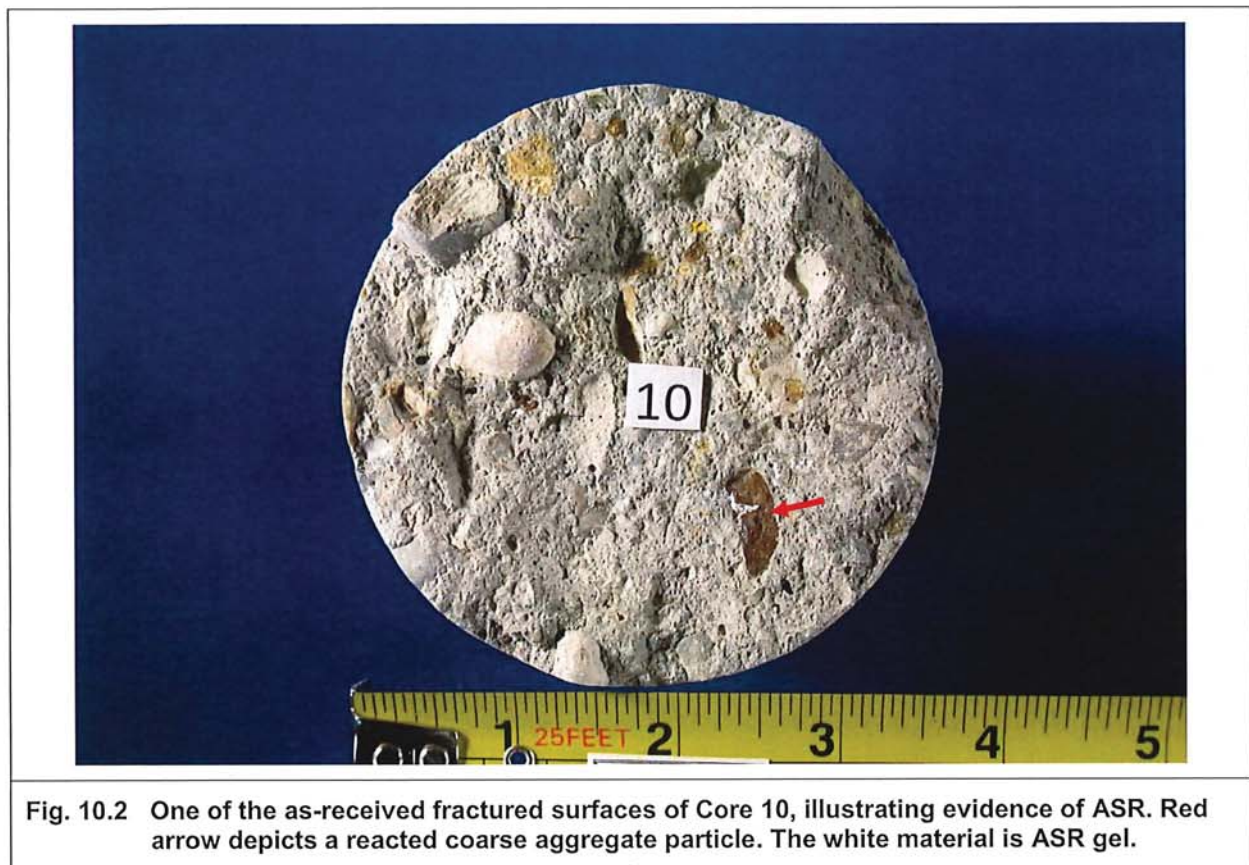
Fig. 10.2 One of the as-received fractured surfaces of Core 10, illustrating evidence of ASR. Red arrow depicts a reacted coarse aggregate particle. The white material is ASR gel.

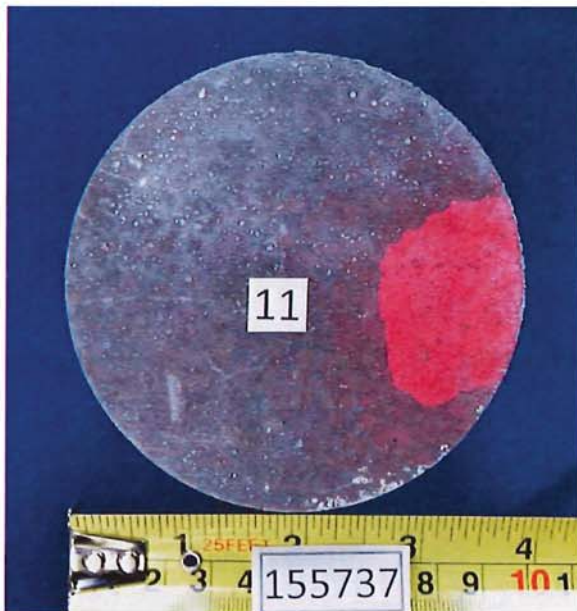
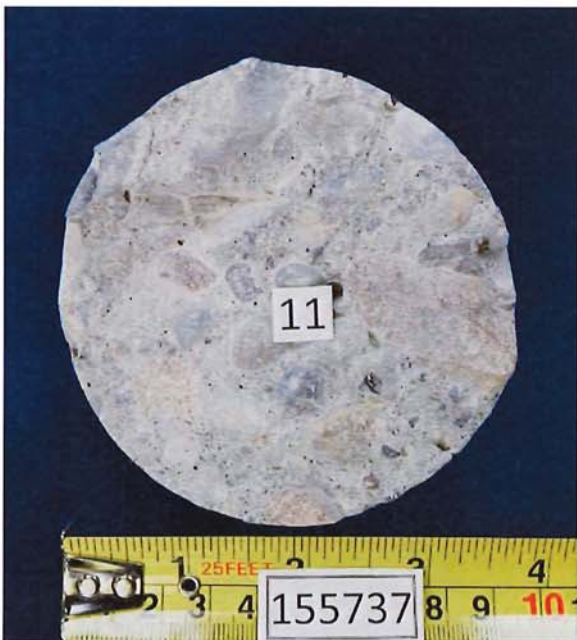
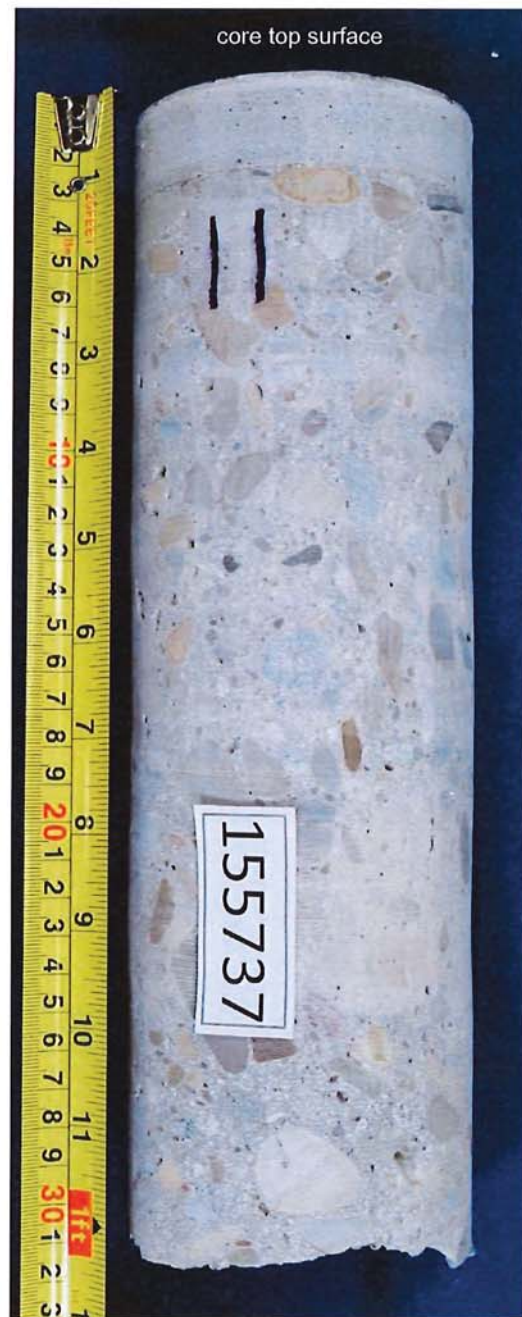
Fig. 11.1 Core 11, as received for testing.

ASR in Concrete: No evidence of ASR observed in core.
