PORT COMMISSION AGENDA REGULAR MEETING MAY 9, 2018 AT 7:00PM VENTURA PORT DISTRICT OFFICE 1603 ANCHORS WAY DRIVE, VENTURA, CA

Ventura Port District
Ventura Harbor Commercial Fish Pier Condition Assessment
Job No. 887-18

Report for
Noble Consultants, Inc.
2201 DuPont Drive #830, Irvine, California 92612

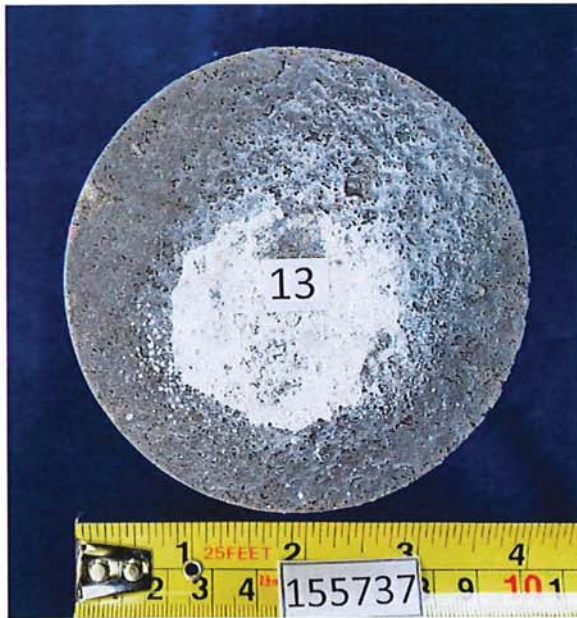
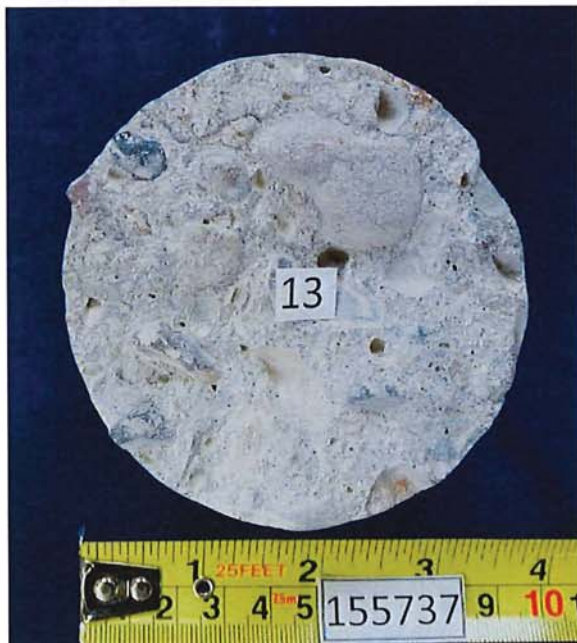
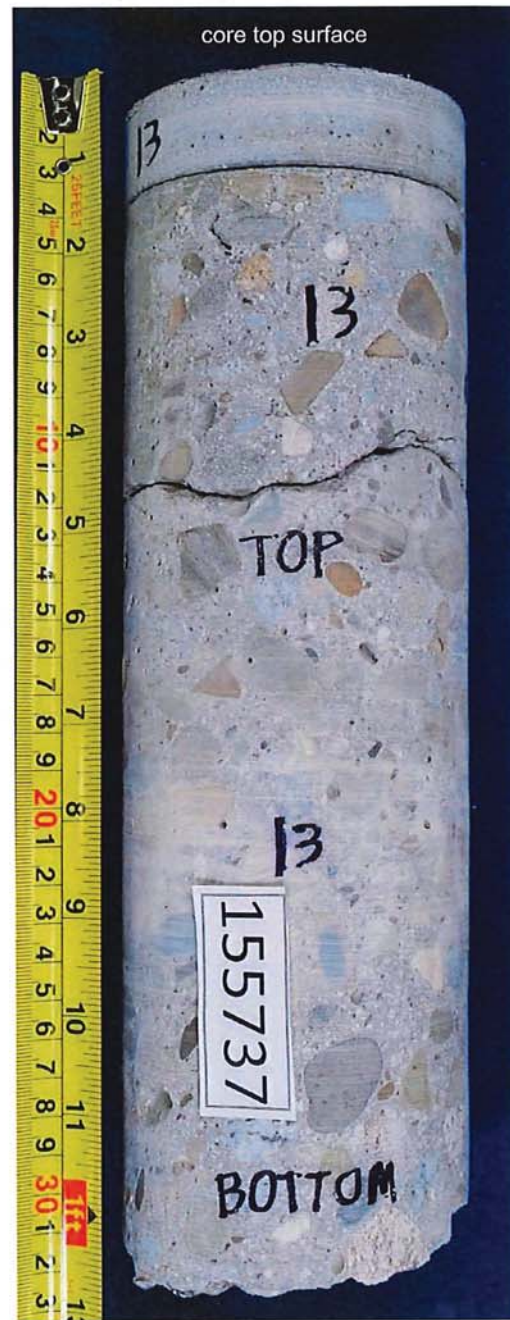
Fig. 13.1 Core 13, as received for testing.

ASR in Concrete: The cracks and microcracks within the substrate concrete may or may not be due to ASR. Several aggregate particles have darkened rims, potentially reaction rims; however, no ASR gel deposits are observed.

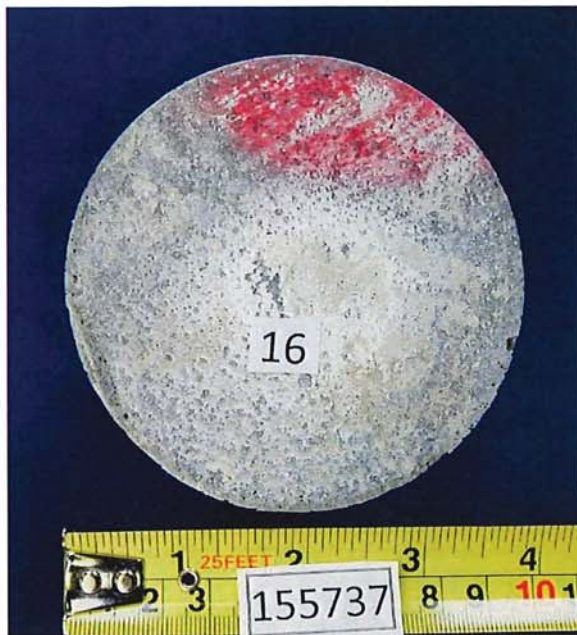
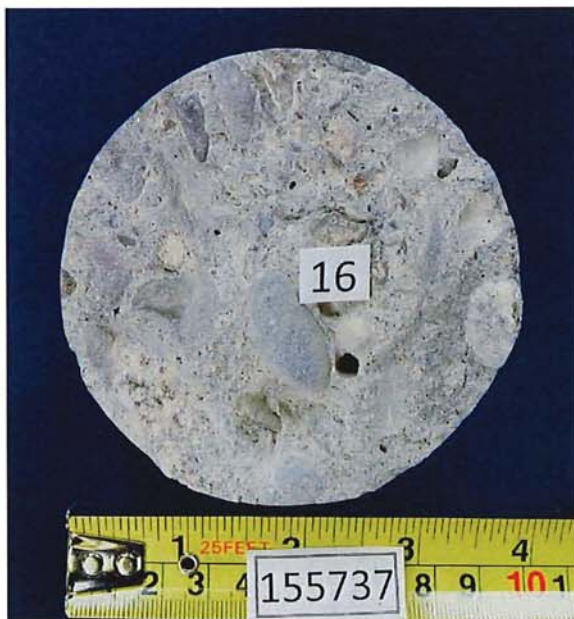
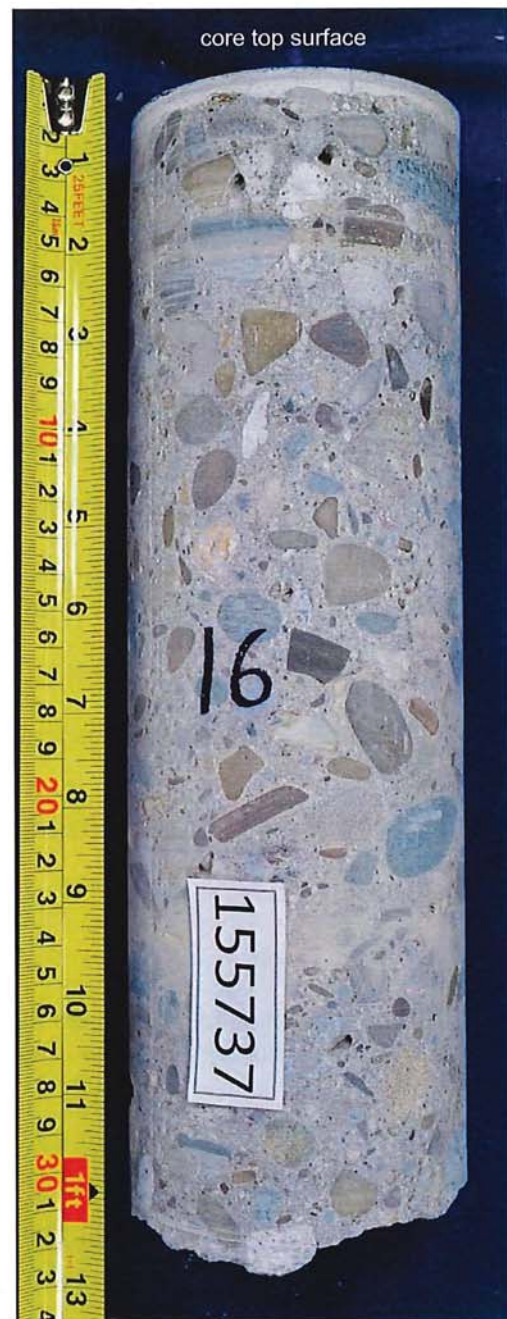
Fig. 16.1 Core 16, as received for testing.

ASR in Concrete: The microcracks within the substrate concrete cannot be discerned as being due to ASR. Several aggregate particles have darkened rims, potentially reaction rims; however, no ASR gel deposits are observed.

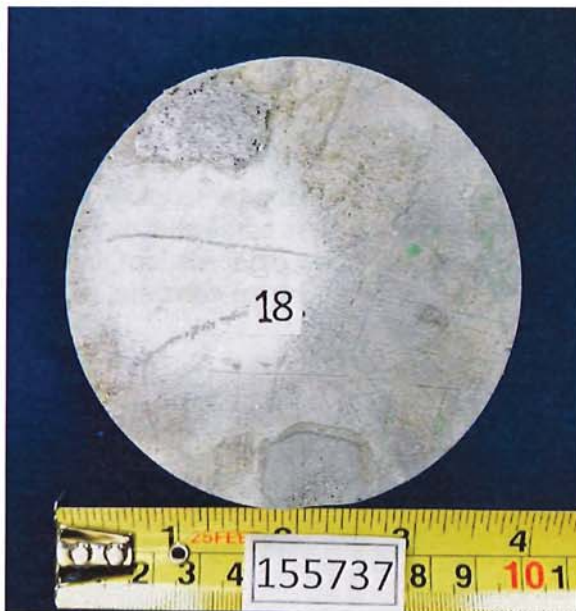
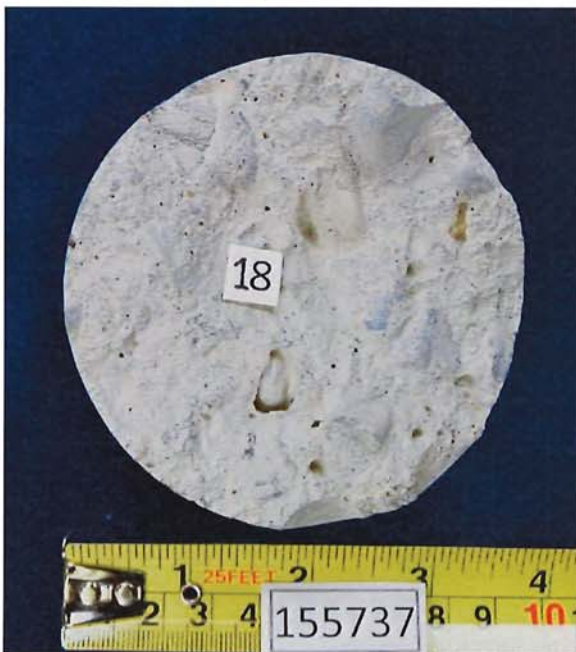
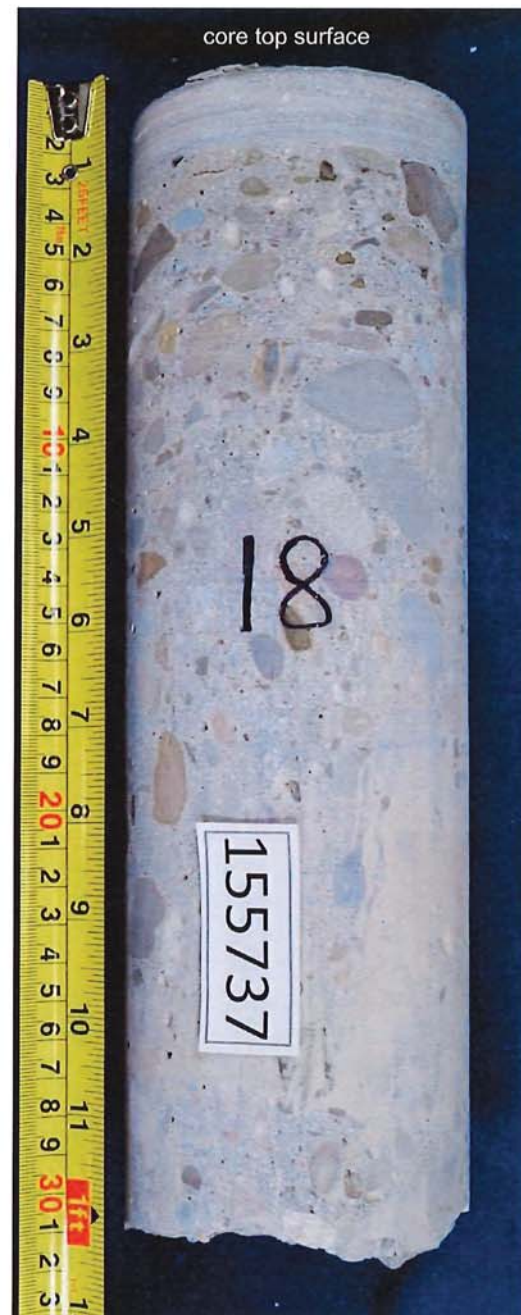
Fig. 18.1 Core 18, as received for testing.

ASR in Concrete: The random microcracks within the substrate concrete may or may not be due to ASR. Several aggregate particles have darkened rims, potentially reaction rims; however, no ASR gel deposits are observed.

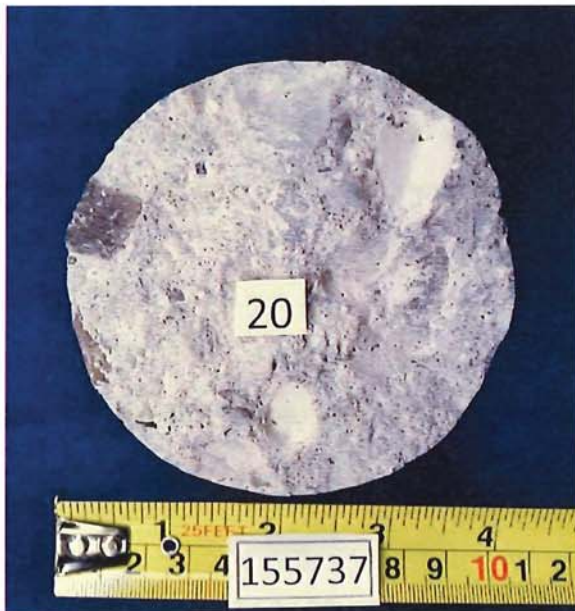
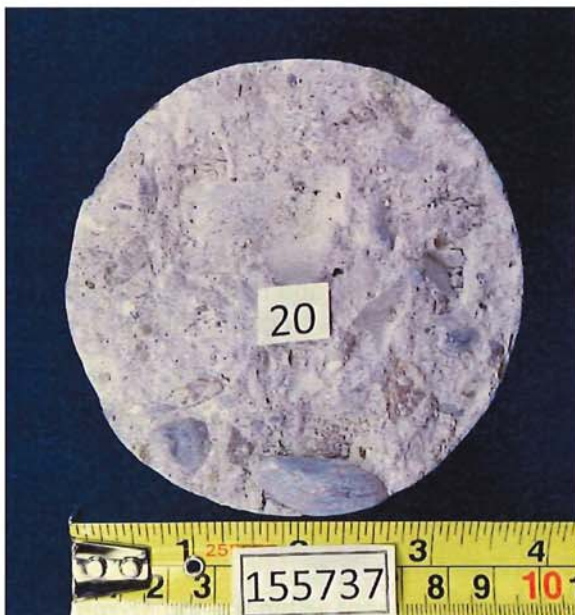
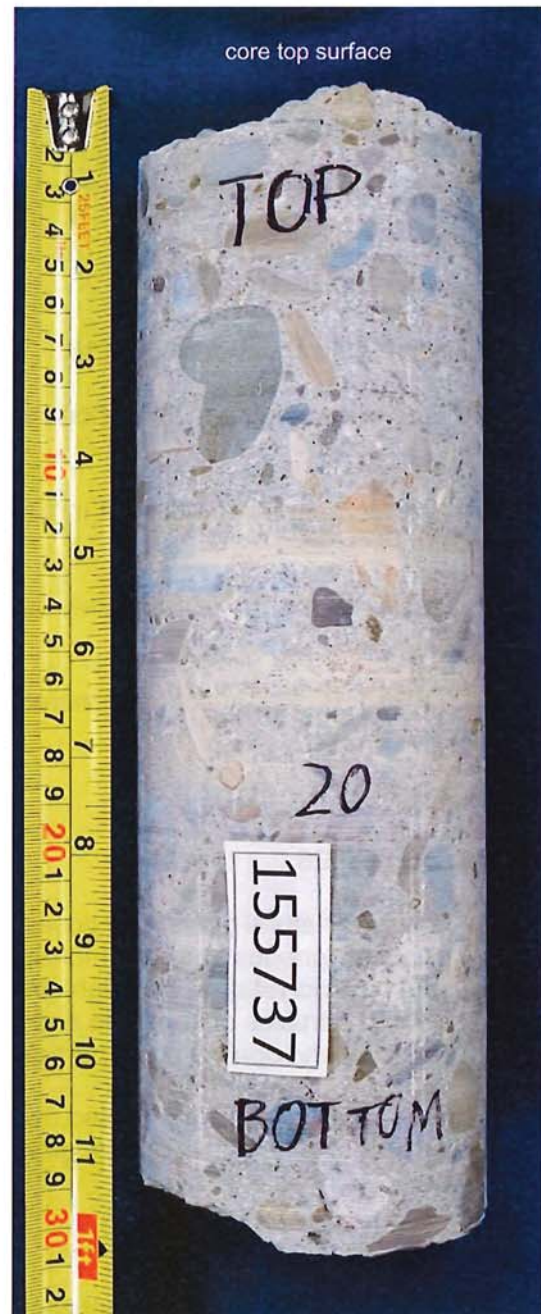
Fig. 20.1 Core 20, as received for testing.

ASR in Concrete: The microcracks within the substrate concrete cannot be discerned as being due to ASR. Several aggregate particles have darkened rims, potentially reaction rims; however, no ASR gel deposits are observed.
